HE	LIDECK INF	ORMATION P	PLATE
1. Operating Company Logo		2. Position		3. Location Name
A J J - - #		27° 21.7272' N 90° 10.8834' W		
Anadarka	A	4. Helideck Identificati	on Marking	MARCO POLO
		MARCO	POLO GC 608

HELIDECK INFORMATION PLATE

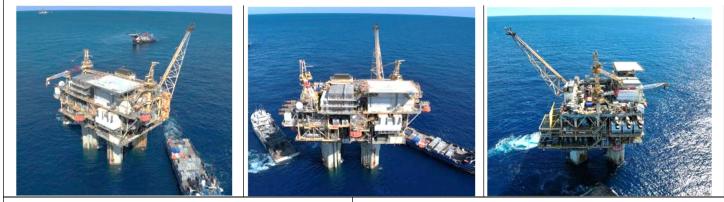
19. Installation Pictures

West lifeboat infringes on OFDS Max. Allowable Mass	
 When cradled the west crane infringes on the OFDS. Cables from crane tip to gantry infringe on OFS. East exit stairwell and lifeboat infringe on OFDS.

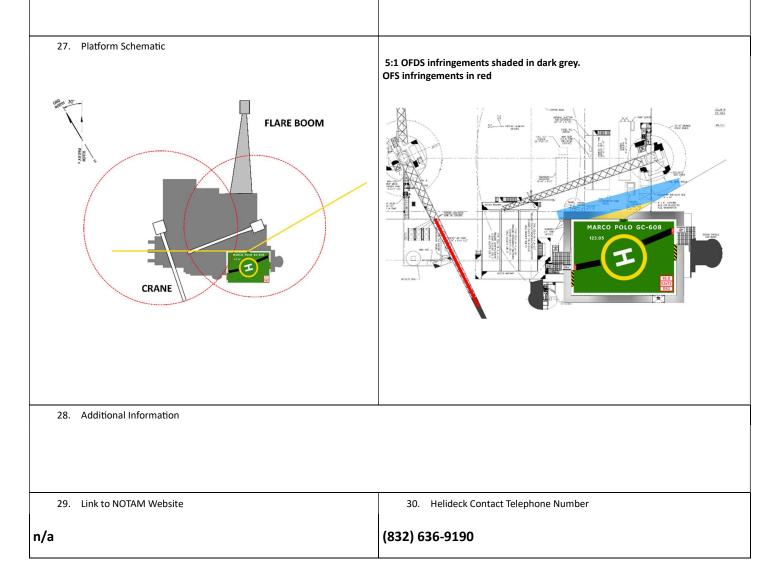
26. Helideck Picture

Note: The Helideck was repainted in Jan 2024.

Manipulated image to show current helideck markings.
