# HELIDECK INFORMATION PLATE

2. Position <p style="text-align: center;"><b>N 27° 17.5326' W 90° 58.0812'</b></p>		3. Location Name  <h2 style="text-align: center;">CONSTITUTION</h2>

4. Helideck Identification Marking  <p style="text-align: center;"><b>GC 680</b></p>					
5. Operating Company  <p style="text-align: center;"><b>Anadarko US Offshore LLC</b></p>	6. Helideck D-Value  <p style="text-align: center;"><b>52 ft / 16m</b></p>	7. Helideck Elevation  <p style="text-align: center;"><b>175.0 ft / 53m</b></p>	8. Lease Block Number  <p style="text-align: center;"><b>GC 680</b></p>

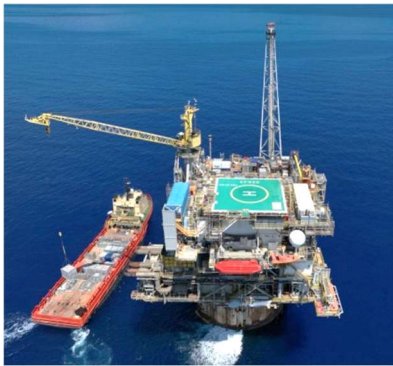
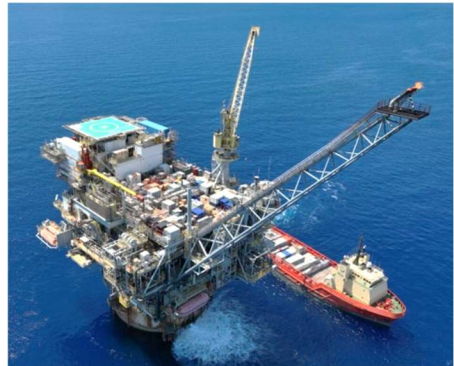
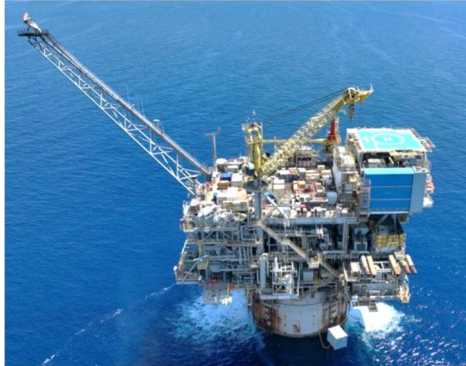
19. Installation Pictures  <div style="display: flex; justify-content: space-around;">

</div>					
20. Deviations from CAP437 or HSAC RPs <ul style="list-style-type: none"> <li>• <b>East crane infringes on OFS.</b></li> <li>• <b>OFDS infringements on east and west sides.</b></li> <li>• <b>Black &amp; Yellow chevron markings on helideck perimeter line do not reflect OFDS infringement areas.</b></li> <li>• <b>TDPM and 'H' lines narrower than HSAC RP161</b></li> </ul>			21. Parking Area Information  Type <b>N/A</b> D-Value Dimensions Max. Allowable Mass Procedures

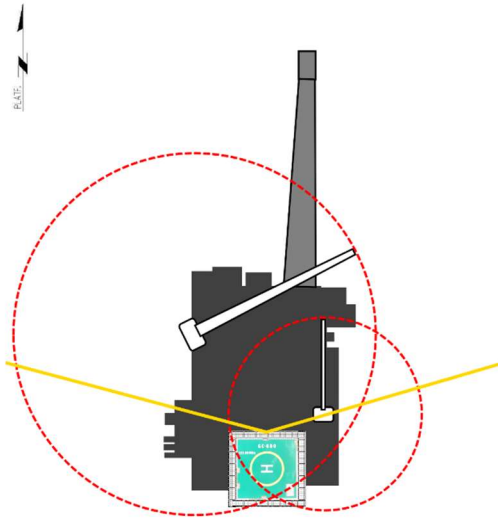
27. Platform Schematic  
Platform North shown.

13. Limitations  <p><b>Use caution with placement of tail rotor due to secondary exit to the south.</b></p> <p><b>Use caution when approaching or departing from/to the east due to OFS infringement of crane gantry.</b></p>		14. TDPM/Aiming Circle <input checked="" type="checkbox"/> Yes <input type="checkbox"/> No <input type="checkbox"/> Displaced 0.1D	15. Weather/ATIS/AWOS ID: TEL: FREQ:  <p style="text-align: center;"><b>No onsite weather station</b></p>

Note: OFS infringement in red, 5:1 OFDS infringements in grey

East crane replacement planned. New crane cab and gantry will be significantly higher above the helideck.
